# Hazemag crusher incident

## Hazemag crusher at Clee Hill Quarry in the Central Region.

LOCATION:	QUARRY	ALERT STATUS:	Normal
ACTIVITY:	PRODUCTION AND PROCESSING	DATE ISSUED:	28/07/2006
SUB ACTIVITY:	FACE ACTIVITY	INCIDENT No:	00107

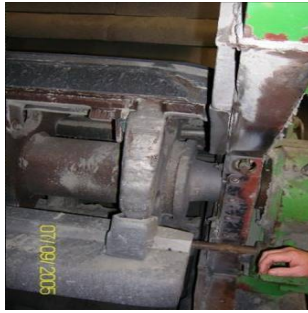
On the 17th June 2005, two employees were tasked to change the blow bars of the Hazemag impact crusher – the tertiary crushing operation at the Clee Hill Quarry site. The blow bars are positioned on four arms of a rotor shaft located at 90° to each other. There are two blow bars per arm, each weighing over 100 kg when new. To safely remove the blow bars, a locking pin is inserted into the rotor flange through the crusher casing, and this secures the rotor from movement. Employees can then remove blow bars safely, normally swapping them “old for new” before turning the shaft. On this occasion all blow bars were being removed so the shaft could be inspected. When the first set of bars were removed it was necessary to move the now out-of-balance rotor shaft, to its next position. This is normally undertaken manually by the operatives undertaking the task. As the rotor was moved over to its next position the weight of the out-of-balance rotor created an inertia effect, resulting in one of the employees trapping his finger between the rotor arm and the crusher casing. This resulted in the employee’s middle finger being badly lacerated, requiring several stitches at the local hospital.

This picture shows nip point where the employees finger became trapped against the casing of the crusher and the rotor arm

1. A risk assessment and safe working procedure was not produced.
2. Operator inexperience may have contributed to the incident.
3. Blow Bars had been changed 4 times in 6 days and this may have lead to less attention to detail.
4. The Hazemag maintenance booklet was not adequate to be considered a safe working procedure.
5. A hazardous nip point on the machine was not recognised.

1. A panel of inquiry has been held to determine the factors in this incident.
  2. Alternate safe methods of replacing blow bars are being investigated.
  3. A risk assessment and safe working practice has been developed.
  4. Discussions are being held with Hazemag over the suitability of an indexing device to control the rotor movement.
-
