Tipper Overturn Whilst Unloading

| INCIDENT No: | 00130 |

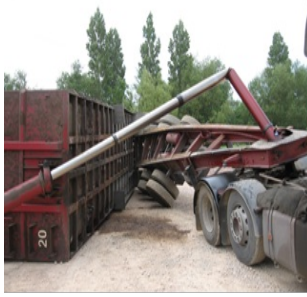
The driver arrived on site and signed in at the weighbridge and made his way to the tipping point. After opening the doors and examining the load he was concerned that the load had settled to one side, against the nearside of the trailer. He then began to tip and noticed the trailer beginning to lean. He lowered the trailer body and asked the loading shovel driver to put a small amount of material in to even the load out. The shovel placed approximately 5 ton into the lorry. The driver then began to tip the load. He climbed out of his cab to check to see if the body was going up squarely. The driver noticed that the body was leaning and went back to the tractor unit to disengage the lifting ram but before he could do this the ram bent and the trailer went over. Fortunately the tractor unit was only lifted a short distance. The primary cause appears to be a build up of load over one side of the trailer body between the rear axle of the tractor unit and the first axle of the trailer. The ground was even and flat.

The aftermath of the event

3. Drivers should be aware that in older trailers, placing additional weight in the area between the rear axle of the tractor unit and the first axle of the trailer is likely to cause increased instability, particularly in those trailers with square sides. Further instability is caused if the load has bound together in this area due to being damp or being loaded unevenly allowing for a sudden shift in weight whilst tipping.

1. Truck drivers should always remain in their cabs, with their seat belt on, when tipping loads.
2. Truck drivers should not attempt to return to their cabs whilst the truck is tipping over! See point 1.

4. Loading shovel drivers should avoid placing additional material into trailers in order to 'even the load'. Should a hazard be identified then better communication between loader driver, weighbridge clerk and site management is paramount. A thorough assessment of risk should have been carried out.
