Tipper Overturn Whilst Unloading

ALERT STATUS: Normal
DATE ISSUED: 10/07/2007
INCIDENT No: 00130

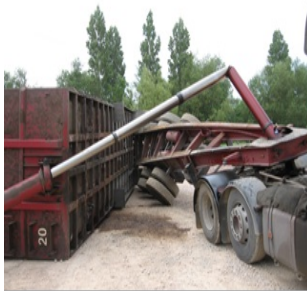
The driver arrived on site and signed in at the weighbridge and made his way to the tipping point. After opening the doors and examining the load he was concerned that the load had settled to one side, against the nearside of the trailer. He then began to tip and noticed the trailer beginning to lean. He lowered the trailer body and asked the loading shovel driver to put a small amount of material in to even the load out. The shovel placed approximately 5 ton into the lorry. The driver then began to tip the load. He climbed out of his cab to check to see if the body was going up squarely. The driver noticed that the body was leaning and went back to the tractor unit to disengage the lifting ram but before he could do this the ram bent and the trailer went over. Fortunately the tractor unit was only lifted a short distance. The primary cause appears to be a build up of load over one side of the trailer body between the rear axle of the tractor unit and the first axle of the trailer. The ground was even and flat.

The aftermath of the event

3. Drivers should be aware that in older trailers, placing additional weight in the area between the rear axle of the tractor unit and the first axle of the trailer is likely to cause increased instability, particularly in those trailers with square sides. Further instability is caused if the load has bound together in this area due to being damp or being loaded unevenly allowing for a sudden shift in weight whilst tipping.

1. Truck drivers should always remain in their cabs, with their seat belt on, when tipping loads.
2. Truck drivers should not attempt to return to their cabs whilst the truck is tipping over! See point 1.

4. Loading shovel drivers should avoid placing additional material into trailers in order to 'even the load'. Should a hazard be identified then better communication between loader driver, weighbridge clerk and site management is paramount. A thorough assessment of risk should have been carried out.
