# Tipper Overturn Whilst Unloading

**ALERT STATUS:** Normal  
**DATE ISSUED:** 10/07/2007  
**INCIDENT No:** 00130

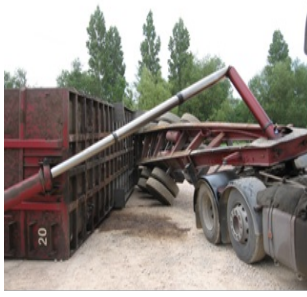
The driver arrived on site and signed in at the weighbridge and made his way to the tipping point. After opening the doors and examining the load he was concerned that the load had settled to one side, against the nearside of the trailer. He then began to tip and noticed the trailer beginning to lean. He lowered the trailer body and asked the loading shovel driver to put a small amount of material in to even the load out. The shovel placed approximately 5 ton into the lorry. The driver then began to tip the load. He climbed out of his cab to check to see if the body was going up squarely. The driver noticed that the body was leaning and went back to the tractor unit to disengage the lifting ram but before he could do this the ram bent and the trailer went over. Fortunately the tractor unit was only lifted a short distance. The primary cause appears to be a build up of load over one side of the trailer body between the rear axle of the tractor unit and the first axle of the trailer. The ground was even and flat.

The aftermath of the event

3. Drivers should be aware that in older trailers, placing additional weight in the area between the rear axle of the tractor unit and the first axle of the trailer is likely to cause increased instability, particularly in those trailers with square sides. Further instability is caused if the load has bound together in this area due to being damp or being loaded unevenly allowing for a sudden shift in weight whilst tipping.

1. Truck drivers should always remain in their cabs, with their seat belt on, when tipping loads.
2. Truck drivers should not attempt to return to their cabs whilst the truck is tipping over! See point 1.

4. Loading shovel drivers should avoid placing additional material into trailers in order to 'even the load'. Should a hazard be identified then better communication between loader driver, weighbridge clerk and site management is paramount. A thorough assessment of risk should have been carried out.
