Neck strain sustained whilst descending from loading shovel

ALERT STATUS: Normal
DATE ISSUED: 11/07/2007
INCIDENT No: 00131

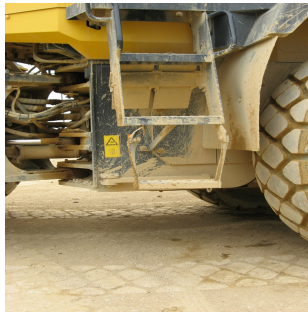
Steps leading down from loading shovel

The investigation found that although the driver descended in the correct manner, the flexible step moved and caused him to strain while attempting to find his footing. The step had also suffered some damage and the bracket was bent as a result. Additional findings show that mudguard sizes differ and in some cases are absent. This increases the likelihood of the step becoming muddy \ wet and further underlines the importance of daily \ operator plant checks.

A hydraulic step system has been ordered for the loading shovel. All personnel should be aware of this type of 'flexi' step and where possible, a new step system should be discussed and fitted, similar to the one shown below.

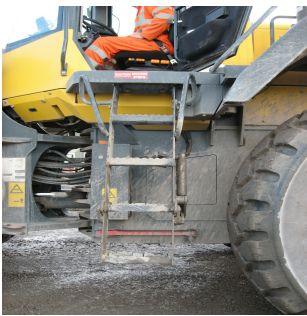
Hydraulic Flexi Step
