# Injury during maintenance work on a Parker Jaw Crusher 1165 Rockranger

ALERT STATUS: Normal  
DATE ISSUED: 10/03/2015 14:27:36  
INCIDENT No: 01407

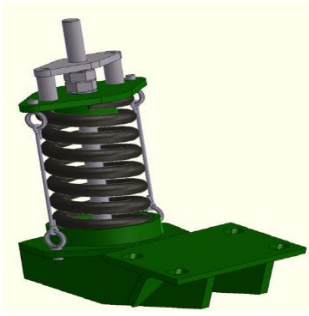
Image shows restraining bars

- New springs have been fabricated with less turns, thus reducing the pressure applied and reducing the chances of the spring bottoming out if an item gets stuck in the jaws
- New draw bars will be fitted on all major overhauls
- New draw back guards, with restraining bars fitted to the top collars to prevent a recurrence.
