Operative Struck by Roller

LOCATION:	ON-HIGHWAY	ALERT STATUS:	Normal
ACTIVITY:	PRODUCTION AND PROCESSING	DATE ISSUED:	13/03/2015 11:54:14
SUB ACTIVITY:	ASPHALT & COATED STONE	INCIDENT No:	01409

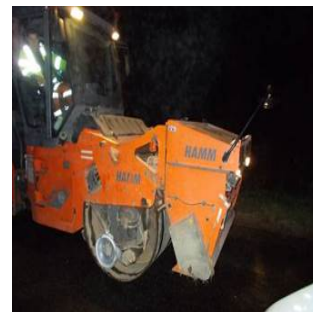
- The existing front headlamps on the roller were not isolated when the grit box attachment was fitted to the roller. This resulted in lighting glare reflecting back into the roller cab further impairing the drivers vision.
- The operative was under the misapprehension that the roller driver was aware of his presence.
- The operative and the roller driver failed to adequately communicate with each other which resulted in neither of them knowing what the other was doing.

Front Lights Not Isolated

- Ensure all similar grit box rollers (Hamm HD90) are inspected to ensure that the front roller lights are either isolated or covered when the grit box attachment is fitted.

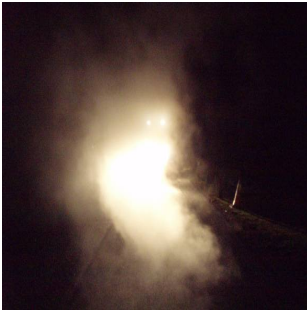
- The roller driver stated that at no time did he see the operative return to the area being rolled.
- The roller driver's visibility was severely impaired due to excessive amounts of steam generated during the rolling operation. This was due to the

low temperatures and high humidity at the time.

Steam reducing visibilty

- Consider the cancellation / suspension of work (in discussion with client) where adverse weather is forecast and there is the potential for excessive steam to be generated, which may cause severe visibility restrictions for site personnel and/or the travelling public.
