Operative Struck by Roller

INCIDENT No:

01409

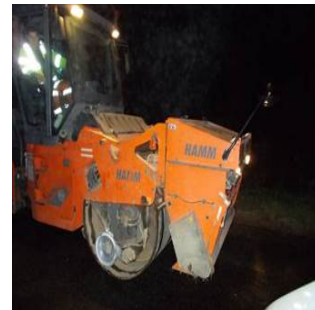
- The existing front headlamps on the roller were not isolated when the grit box attachment was fitted to the roller. This resulted in lighting glare reflecting back into the roller cab further impairing the drivers vision.
- The operative was under the misapprehension that the roller driver was aware of his presence.
- The operative and the roller driver failed to adequately communicate with each other which resulted in neither of them knowing what the other was doing.

Front Lights Not Isolated

- Ensure all similar grit box rollers (Hamm HD90) are inspected to ensure that the front roller lights are either isolated or covered when the grit box attachment is fitted.
