# Tipper Body Floor (Steel Liners)

LOCATION:	ON-HIGHWAY	ALERT STATUS:	Normal
ACTIVITY:	TRANSPORT & LOGISTICS / DELIVERY	DATE ISSUED:	24/06/2015 11:22:58
SUB ACTIVITY:	TIPPER	INCIDENT No:	01416

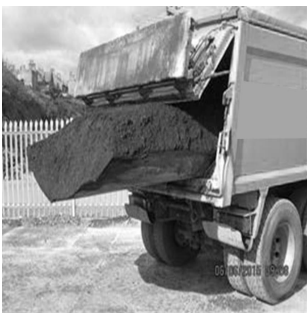
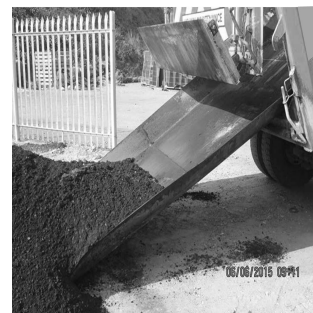
Recently on a contract surfacing site; a tipper truck was delivering asphalt to a machine lay operation. During the discharge of the load, the tipper body floor as a whole moved, as illustrated in the photographs.

After investigation it appears that the cause of the failure was that the fixings used to secure the liner to the body had corroded and failed as a result of galvanic corrosion, which is an electrochemical process. There has been a reaction between the alloy body and steel liner, which has caused the fixings to corrode and fail.

Since this incident, all the steel inserts have been thoroughly inspected and a replacement programme to fit an aluminium welded floor is underway. These trucks have been taken off asphalt deliveries until these steel inserts have been removed.

Truck drivers were instructed to inspect the tipper body floor as part of the daily checks for wear etc. and to report any defects immediately.
