# Catastrophic failure of clamp on forklift

**ALERT STATUS:** Normal  
**DATE ISSUED:** 27/04/2016 15:34:34  
**INCIDENT No:** 01429

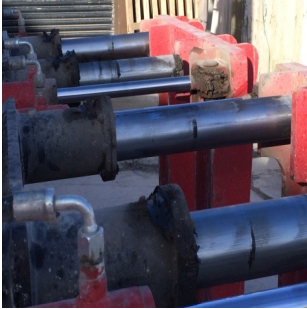
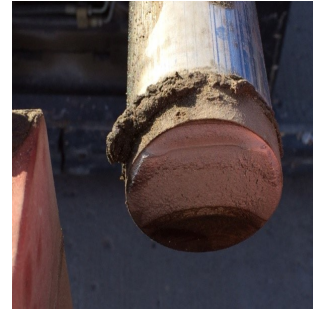
A clamp which was attached to a Linde HD 50 forklift failed catastrophically when a steel rod sheared. This resulted in a pack being dropped as it was being placed on the ground. The incident could have been much worse as packs can be stacked 4 to 5 cubes high at full extension. No injury occurred during the incident, but the potential was far greater. Investigations identified that the clamp and truck had been in service just under three years and that the clamp attachment had been serviced within the last 9-10 months.

Sheared rod on clamp

- The service of the clamp attachment and inspection routines failed to pick up this fault
- Existing clamp attachments should be checked / inspected by NDT to ensure they are crack free
- Amend service routine to cover NDT of area of rod that failed
- Review frequency of inspection and service
