Catastrophic failure of clamp on forklift

LOCATION: CONCRETE PRODUCTS PLANT
ACTIVITY: MANUAL HANDLING AND STORAGE
SUB ACTIVITY: N/A

ALERT STATUS: Normal
DATE ISSUED: 27/04/2016 15:34:34
INCIDENT No: 01429

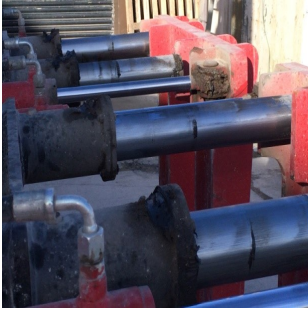
A clamp which was attached to a Linde HD 50 forklift failed catastrophically when a steel rod sheared. This resulted in a pack being dropped as it was being placed on the ground. The incident could have been much worse as packs can be stacked 4 to 5 cubes high at full extension. No injury occurred during the incident, but the potential was far greater. Investigations identified that the clamp and truck had been in service just under three years and that the clamp attachment had been serviced within the last 9-10 months.

Sheared rod on clamp

- The service of the clamp attachment and inspection routines failed to pick up this fault
- Existing clamp attachments should be checked / inspected by NDT to ensure they are crack free
- Amend service routine to cover NDT of area of rod that failed
- Review frequency of inspection and service
