Tyre fitter trapped under foam filled tyre

ALERT STATUS: Normal
DATE ISSUED: 31/05/2016 12:13:15
INCIDENT No: 01432

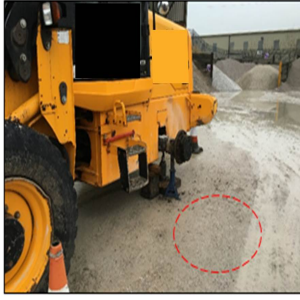
A contract tyre fitter (IP) working on a hired loading shovel suffered bruising to his right arm and left leg after becoming trapped beneath a foam filled tyre and wheel assembly, when the tyre fell onto him after he unbolted the wheel in preparation for changing the tyre - see Photograph 1.

- The loading shovel was on hire and neither the Company nor the tyre fitter knew the tyre was foam filled.
- The IP assumed it was a punctured air-filled tyre because it had deflated (the foam inside the tyre had deteriorated giving the appearance of a punctured pneumatic tyre – foam tyres don't normally deflate).
- The foam filled tyre weighed in excess of 400kg (two or three times heavier than an air filled tyre). It took two people to lift the tyre off the trapped fitter.
