# Collapse of concrete flooring during construction

<b>LOCATION:</b>	<b>CONCRETE PRODUCTS PLANT</b>	<b>ALERT STATUS:</b>	<b>Normal</b>
<b>ACTIVITY:</b>	<b>LIFTING</b>	<b>DATE ISSUED:</b>	<b>29/07/2016 12:16:52</b>
<b>SUB ACTIVITY:</b>	<b>NO SUB ACTIVITY AVAILABLE</b>	<b>INCIDENT No:</b>	<b>01437</b>

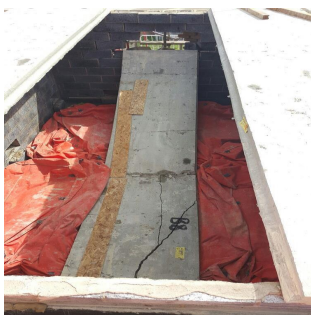
An incident recently occurred during the construction phase of a housing development. A precast concrete hollowcore flooring slab fell from first floor level onto the ground below. No persons were injured.

Through a detailed study of process data and product testing the investigation has concluded that the incident was not a result of product failure.

Fig. 1 - Damaged slab on ground

Responsible persons should be reminded of the importance of carrying out suitable and sufficient pre / post installation inspection (with should include ensuring no damage in transit or installation and the suitability of load bearing points)

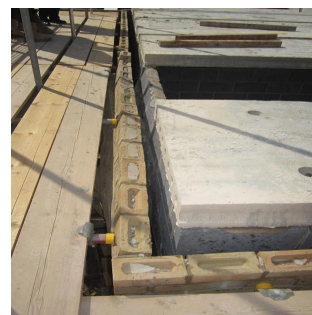
Whilst investigations are still ongoing, it appears that there were only two probable causes for the occurrence:

- (i) Failure of the bearing (reason unknown), or
- (ii) The slab being dislodged from its bearing.

Fig. 2 - Supporting masonry
