Quarry Drill Rig: Serious Incident

LOCATION:	QUARRY	ALERT STATUS:	Normal
ACTIVITY:	PRODUCTION AND PROCESSING	DATE ISSUED:	14/03/2017 14:53:27
SUB ACTIVITY:	FACE ACTIVITY	INCIDENT No:	01446

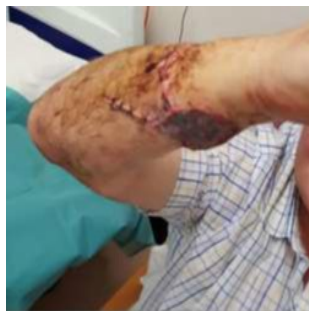
A Drill Rig operative sustained a broken lower right arm as a result of entrapment on a drill rod carousel while changing a sensor.

The initial investigation has identified that the safety sensor (pad) in the seat of the drill rig had been disconnected allowing the operator to leave his seat in the cab and work on the drill carousel without appropriate isolation.

Injured Arm

Inspect all drill rigs to confirm the seat safety sensor (pad) is in place and functional.

Review and update their Drill Rig pre-start checks to include the seat safety sensor (pad) is in place and functional.

Review all drilling operational procedures and re brief all Drill Rig operatives to confirm their understanding.

Ensure that maintenance on drill rigs is only undertaken by trained and authorised maintenance personnel.

Review Drill Rig operative lone worker procedures.
