Lifting Operation LTI

LOCATION: AGGREGATE DREDGER
ACTIVITY: MAINTENANCE & HOUSEKEEPING
SUB ACTIVITY: N/A

ALERT STATUS: Normal
DATE ISSUED: 04/07/2017 10:32:47
INCIDENT No: 01458

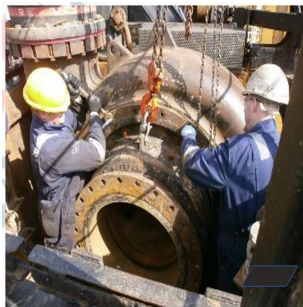
Final reassembly of the pump was being conducted. This involved using a crane on the shore to lift the pump cover back into place. The pump cover is 1.5m in diameter and weighs 1.5 tonnes. The cover must be closely guided back into position - hence the two contractors were in close proximity. A banksman was guiding the crane. Location of the cover onto the spigot was at an upward angle, due to the trim of the vessel.

Whilst attempting to fit the cover, it came off the spigot and moved unexpectedly, swinging and striking the two contractors. The cover did not drop. Both contractors were taken to hospital. One was released that evening with minor injuries and the other sustained fractured ribs and was kept in overnight (LTI).

- Crane positioning could have been closer on the quay.
- Fine positioning is not easy using just the crane controls. A chain block should have been used to allow local control.
- Preventer studs on the pump door would allow for initial alignment to be achieved without having people in such close proximity.
