Bulk Tipper Trailer Ram Failure

ALERT STATUS: Normal
DATE ISSUED: 12/10/2017 12:21:43
INCIDENT No: 01473

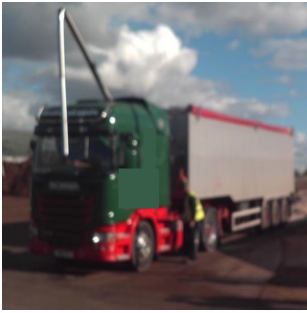
Whilst a load was being discharged from a bulk tipper onto a storage pad, the top ram mounting bolts failed. This resulted in the unsupported trailer body falling approximately 15 metres onto the chassis and the tipping ram striking the top of tractor unit cab.

Final Ram Position

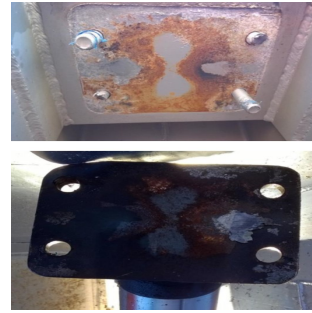
- Tipper ram was fully extended
- Load was not free-flowing
- Driver moved trailer < 2metres to discharge load
- Tipper ram was not connected to trailer
- 4 mechanical fasteners had failed (2 had sheared off and there was evidence of metal fatigue, 2 had stripped off nyloc nuts from threads)
- Trailer was first registered 07.11.13

Trailer Tipper Ram Mountings

Ensure that any inspection and maintenance regime, takes into account other critical components that are not part of a mandatory VOSA inspection regime; in this case, the ram top mounting fasteners.

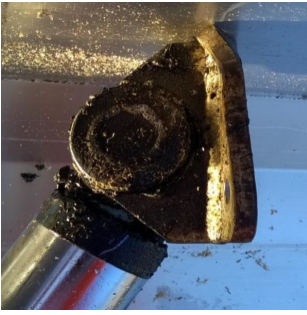
- Two of the mechanical fasteners showed evidence of metal fatigue
- The inspection and maintenance regime had been ineffective
- Fixings are not part of the mandatory Vehicle Operator Services Agency (VOSA) inspection regime

Trailer Tipper Ram Mountings

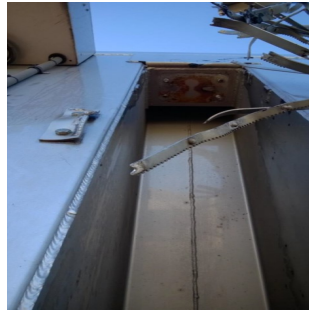
Top of Tipper Ram Mounting Plate
