FEL Contact with Customer Vehicle

LOCATION: ASPHALT/COATING PLANT
ACTIVITY: TRANSPORT & LOGISTICS / DELIVERY
SUB ACTIVITY: LOADING

ALERT STATUS: Normal
DATE ISSUED: 07/11/2017 11:49:13
INCIDENT No: 01477

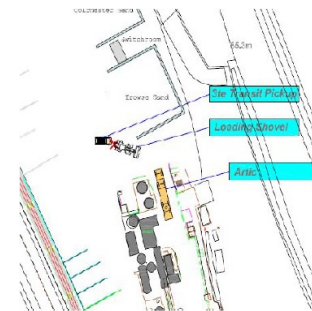
Position of Vehicles

The driver went to drive around to the front of the plant when he noticed an arctic coming towards him. He reversed to allow the arctic to pass, not noticing the collect customer in a transit van who had driven up behind the FEL. The counter weight of the FEL came into contact with the customer vehicle causing minor damage to the vehicle.

- Ensure hauliers who are new to site have an induction / orientation to warn of site hazards and that this is recorded.
- Review Vehicle/Pedestrian Management Plan to ensure that, wherever possible, site vehicles are separated from road vehicles on site.
- In restricted plants consider adopting a '5+2' rule where a 5m exclusion zone is enforced in front and behind a vehicle and 2m either side.
- Share this brief with staff showing the dangers of not checking behind adequately when reversing.
- Verify that VMS / Radar systems on mobile plant have been subject to risk assessment and have been calibrated to the working area and is effective.
- Review daily mobile plant inspections to ensure that all defects are being reported as required.
