Fatal 6 - Receiving hopper collapse

READYMIX OR MORTAR PLANT
PRODUCTION AND PROCESSING
READYMIX

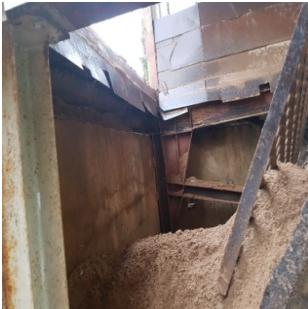
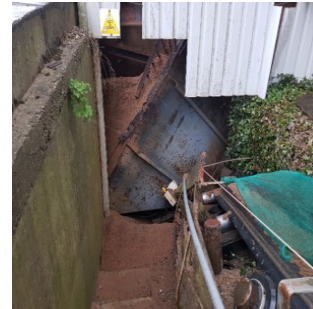
Sand was being discharged by an articulated tipper truck into the receiving hopper at a Readymix plant. Due to the restricted size of the hopper, only part of the load could be tipped. It is difficult to judge the amount of sand tipped, as it can surge. While the vehicle was tipping off the second part of the load, the hopper supports suddenly gave way and the hopper fell into the pit below, crushing the conveyor structure beneath.

- The plant is 51 years old and initially designed for a 17 year service life; it is thought that the hopper was the original
- Deliveries to site were changed to articulated tipper trucks 3 to 4 years ago; however, the hopper was originally designed for Rigid 8-wheel trucks.
- A structural survey had recently been carried out, where repairs had been highlighted to be completed within 3 months, and the removal of platework was recommended to allow investigation and repair of corrosion and checks on the hopper support brackets.
- The design of the support brackets meant if it became detached the hopper could fall away unsupported.

- Prior to a structural survey, ensure all areas of the plant are cleared and additional supports are removed to assess the plants physical condition.
- Use trucks with a smaller payload as per the original design of the hopper.

- Structural survey programmes should be in place for all plants by competent engineers
- Ensure engineers have access to fully assess structures
- Complete structural repairs on time
- Consult with the engineers if any repairs are to be deferred
- Restrict access beneath hoppers while they are loaded / being loaded.
