Flailing operation on hedgerow puts public at risk - near miss

ALERT STATUS: Normal
DATE ISSUED: 16/08/2019 16:45:23
INCIDENT No: 01526

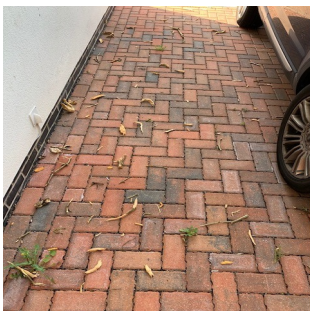
Debris in drive
