## Flailing operation on hedgerow puts public at risk - near miss

**ALERT STATUS:** Normal  
**DATE ISSUED:** 16/08/2019 16:45:23  
**INCIDENT No:** 01526

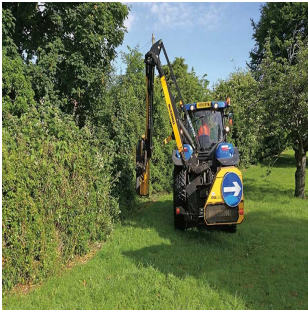
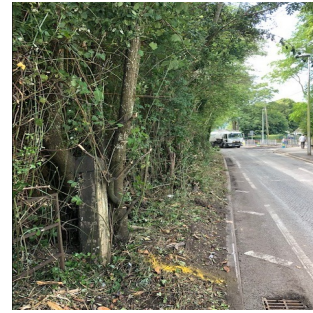
During recent operations by a road surfacing team, part of the work involved cutting back a hedgerow prior to the road surfacing operations. A tractor and flail was used for this operation, the activity resulted in a near miss incident. The hedgerow was 4m thick and the subcontractor undertaking the task was experienced in this type of work. Pedestrians were diverted away from the side of the hedge being cut back. However, despite the completion of a risk assessment, the full impact of the flailing action of the machinery involved had not been considered. There had been insufficient communication with the residential properties on the opposite side of the hedge. It was not foreseen that the operations would affect them. Debris from the flailing exercise travelled through the hedgerow and landed around the property of a resident. No people were harmed but it was by chance that nobody was present when the tractor and flail passed by.

- Technical performance specifications for any machinery used on site must be incorporated into the risk assessment process.
- Prior to commencement of works on a site, all types of machinery must have been considered within the RAMS document.
- The potential impact on members of the public and surrounding property at every step of the process must be considered.

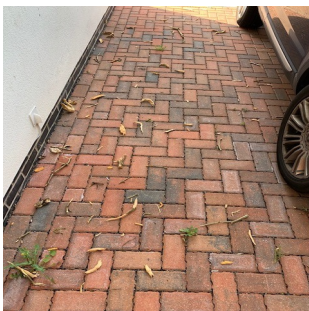
Debris in drive
