# Fatal 6 - Seaman struck by mooring line

BMAPA have issued the following alert outlining how a seaman was injured and the actions that have been recommended to improve mooring procedures following this incident.

<b>LOCATION:</b>	<b>AGGREGATE DREDGER</b>	<b>ALERT STATUS:</b>	<b>Normal</b>
<b>ACTIVITY:</b>	<b>MARINE OPERATIONS</b>	<b>DATE ISSUED:</b>	<b>01/10/2019 11:34:09</b>
<b>SUB ACTIVITY:</b>	<b>SHIP TO SHORE</b>	<b>INCIDENT No:</b>	<b>01528</b>

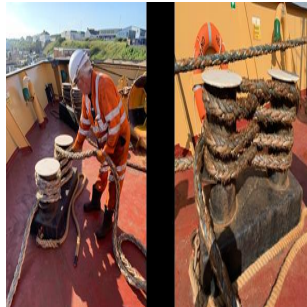
A UK marine aggregate dredger was making a routine entry into a UK port, which necessitated transiting a Lock. As the vessel came into position in the Lock the order to 'hold on' (the spring mooring line) was given and astern pitch applied. The Seaman forward 'turned up' the spring on the mooring bitts (ship's bollard) as instructed.

The vessel continued to move ahead slightly; placing strain on the secured mooring line. The mooring line surged (slipped) on the mooring bitts; the standing (unloaded) part of the line whipped from the deck, striking the Seaman in the groin.

- The mooring equipment in the vessel is undersized by contemporary standards for the rope size in use.
- Mooring equipment standards have been formalised/ amended several time since the vessel was constructed.

- The layout of mooring equipment in the vessel precluded use of best operational practice for use in service.
- Standard induction procedures were followed; however, could have been improved with more focus on ship specific issues.

- Co-ordination of communications and actions of the Bridge Team and instructions given to Deck Crew could be improved.
- Minor proportionate modification to Deck mooring equipment would be beneficial to eliminate an identified deficiency.

- There was no specific mooring plan in place for the task.

- The bridge team should review co-ordination between the timing of instructions given to deck crew and actions executed to control and manage the vessel; to ensure Deck Crew are not subjected to risk during mooring ops.

- The provision of induction refresher training to crew members established in the vessel should be considered.
- A task specific mooring plan should be developed to address the operation of securing the vessel during passage through Locks.

- On-board mooring practice while transiting Locks should be reviewed to determine whether operation of one mooring line at a time would improve safety without compromising other aspects of safe ship operation.

- A study to evaluate modification of the mooring bitts involved in this incident should be undertaken to determine whether a deficiency in layout can be eliminated.
