Fatal 6 - Conveyor LTI - Laceration to arm

ALERT STATUS: Normal
DATE ISSUED: 25/11/2019 09:36:43
INCIDENT No: 01535

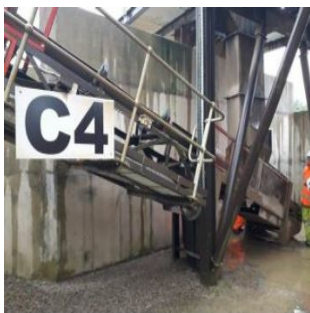
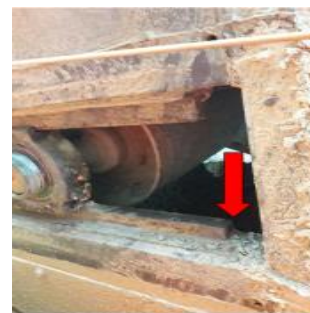
Due to the conveyor running off track, material spilt off the belt at the head and tail drum causing the belt to cut out. As this occurred at the end of the day, production ceased with the intention of addressing the issue the following day.

Due to the incident the previous day, the conveyor was not operated although the primary section of the plant was put into production. For the first hour all employees started cleaning up the spillage and thereafter cleaning was completed by various personnel in between other duties. During this time, no guards were removed and no isolations were in place. By midday the only spillage left was that tight to the conveyor and inside the guards.

After lunch the injured party (IP) had time to continue the spillage clearance. The IP isolated the conveyor and the conveyor anti-run back initiated before removing the guard around the tail drum allowing access to the tail drum. He then proceeded to clear the material with a bar and his hand from between the bottom of the tail drum and the conveyor. The conveyor belt suddenly moved forward (uphill) as the last remaining spillage was cleared nipping the IP's hand between the bottom of the tail drum and the return belt. The return belt had to be cut to release the IP's hand who received a cut to the elbow area of the right arm requiring surgery to clean and stitch.

- No risk assessment undertaken
- IP eagerness to start the task

- No Formal SWP in place
- Failure to wear the correct PPE – Although this would not have prevented the incident, the POL agreed the severity of the Injury would have been reduced

It was agreed to produce a training document to highlight all risks (including all types of stored energy)

PPE: Correct use for different situations (Produce CREW training to demonstrate why we need to use and the consequences of not using correctly)
