# Fatal 6 - Ship's crew struck by falling hose

**LOCATION:** AGGREGATE DREDGER  
**ACTIVITY:** CONTRACTOR SAFETY MANAGEMENT  
**SUB ACTIVITY:** MARINE

**ALERT STATUS:** Normal  
**DATE ISSUED:** 17/12/2019 17:04:16  
**INCIDENT No:** 01541

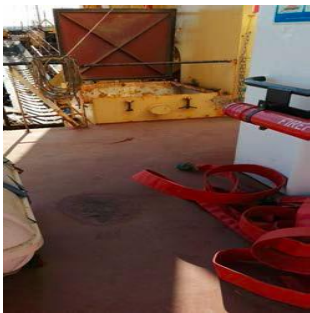
As the hose was hauled up by hand through a hatch, the bayonet connection between the two hose sections caught on the coaming; resulting in the two sections separating. The lower section dropped through the hatch; and, despite a shouted warning, struck the crew member on the forehead; requiring hospital attendance to close the wound.

Site of hose recovery

- Interaction between crew and contractors must be planned; to properly understand the task and apply necessary control measures.
- An appropriate level of assessment must be used for all tasks; including those perceived as low risk or minor.
- First-Aid/ medical treatment must be provided; however, duties must be assigned to ensure an incident scene is preserved; and evidence secured for investigation.
- Compliance with prescribed PPE requirements is mandatory; requirements must be clear to employees and not subject to interpretation.

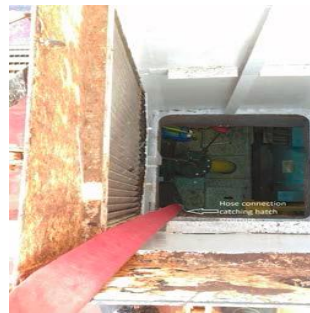
Hatch through which hose was being recovered
