Fatal 6 - Working at height - high potential near hit

LOCATION: AGGREGATE DREDGER
ACTIVITY: ACCESS & EGRESS & WORKING AT HEIGHT
SUB ACTIVITY: N/A

ALERT STATUS: High Potential
DATE ISSUED: 13/01/2020 11:50:26
INCIDENT No: 01543

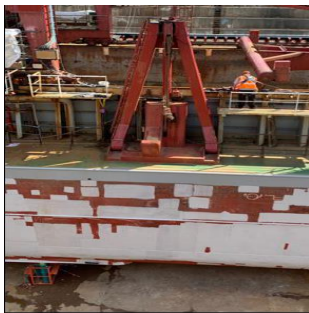
Image 'a'

The Contractor was only wearing a single tail work restraint lanyard (the RA had identified that two lanyards were required for the task). During the work activity the contractor was observed moving off the safety walkway onto the intermediate gantry without using the specified twin lanyards and without clipping his single lanyard to a securing point, thus exposing himself to a potential 10 metre fall (image 'a'). Once reaching the intermediate gantry, the single lanyard was then incorrectly attached to a vertical wire and not to a fixed point. In the event of a potential fall from this point, the lanyard would have slid down the length of the wire rather than arresting the fall (image 'b').

- Vessels should discuss this Safety Alert note at their next Safety Briefing held on-board and ask the question could this incident happen on my watch?
- Vessels should review all activities involving Working at Height and ensure the risk assessments are suitable and sufficient for the activity.
- Masters should include this Safety Alert in their Handover notes to ensure this information is passed onto their opposite watch.
