Fatal 6 - Explosion at an asphalt plant

LOCATION: ASPHALT/COATING PLANT
ACTIVITY: PRODUCTION AND PROCESSING
SUB ACTIVITY: ASPHALT & COATED STONE

ALERT STATUS: Normal
DATE ISSUED: 21/01/2020 12:43:48
INCIDENT No: 01544

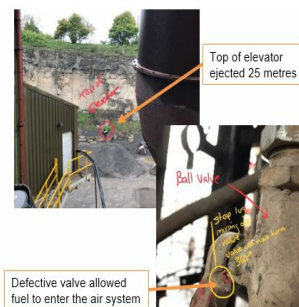
Changes to the production process at an asphalt plant and a faulty isolator valve allowed fuel to enter the aggregate bucket elevator via the pneumatic system.

Contact with the hot aggregate resulted in a build up of flammable gases, which ignited when the plant burner started up, causing an explosion; the explosion was sufficient to blow the top of the tower some distance and cause extensive damage to the tower casing. If anyone had been hit by this, it would have caused a serious injury or fatality.

Note: Changes to the original system design, potentially dating back 30 years, did not consider the danger of back pressure in the fuel system. A subsequent change a few months before the incident meant fuel was being delivered at a higher pressure, which allowed it to enter the air system.

- The original design change to eliminate manually adding fuel to the system was flawed.
- The potential effects of further changes to the system were not fully considered.
- A faulty isolation valve allowed fuel to continue to enter the system after it was turned off.

This could have been avoided through effective management of change and robust inspection and defect reporting of all safety critical equipment.

- Ensure an effective management of change process is followed.
- Effective equipment inspections that includes all safety critical valves
- Encourage defect reporting and ensure action is taken promptly.
