Fatal 6 - Explosion at an asphalt plant

LOCATION: ASPHALT/COATING PLANT
ACTIVITY: PRODUCTION AND PROCESSING
SUB ACTIVITY: ASPHALT & COATED STONE

ALERT STATUS: Normal
DATE ISSUED: 21/01/2020 12:43:48
INCIDENT No: 01544

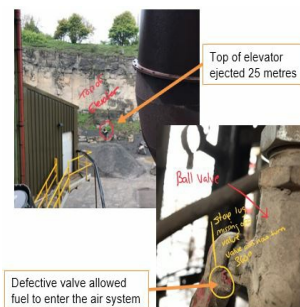
Changes to the production process at an asphalt plant and a faulty isolator valve allowed fuel to enter the aggregate bucket elevator via the pneumatic system.

Contact with the hot aggregate resulted in a build up of flammable gases, which ignited when the plant burner started up, causing an explosion; the explosion was sufficient to blow the top of the tower some distance and cause extensive damage to the tower casing. If anyone had been hit by this, it would have caused a serious injury or fatality.

Note: Changes to the original system design, potentially dating back 30 years, did not consider the danger of back pressure in the fuel system. A subsequent change a few months before the incident meant fuel was being delivered at a higher pressure, which allowed it to enter the air system.

- Ensure an effective management of change process is followed.
- Effective equipment inspections that includes all safety critical valves
- Encourage defect reporting and ensure action is taken promptly.
