# Finger dislocation on induction tour - BMAPA alert

LOCATION:	AGGREGATE DREDGER	ALERT STATUS:	Normal
ACTIVITY:	MARINE OPERATIONS	DATE ISSUED:	17/06/2020 16:49:12
SUB ACTIVITY:	DREDGING	INCIDENT No:	02564

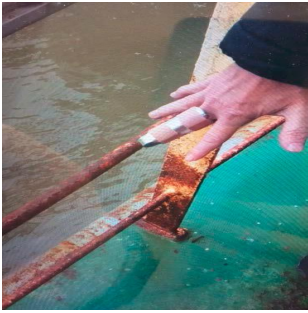
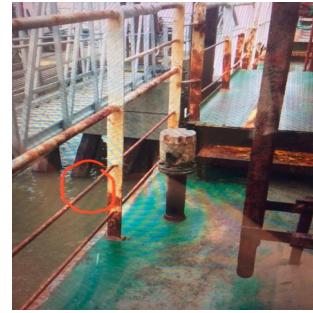
During this walk around the IP lost his footing on a rogue stone on the safety walkway put out his hand to steady himself and caught his finger on the middle safety railing causing it to bend back and dislocate.

Vessels to conduct a Safety Briefing discussing the above incident highlighting the importance of conducting a good briefing with new unfamiliar crew members before conducting a tour of the vessel, reminding of the importance of being vigilant when conducting routine activities.
