# Near Miss - Falling Object

**LOCATION:** ASPHALT/COATING PLANT  
**ACTIVITY:** MAINTENANCE & HOUSEKEEPING  
**SUB ACTIVITY:** N/A

**ALERT STATUS:** Normal  
**DATE ISSUED:** 12/08/2020 10:46:56  
**INCIDENT No:** 02566

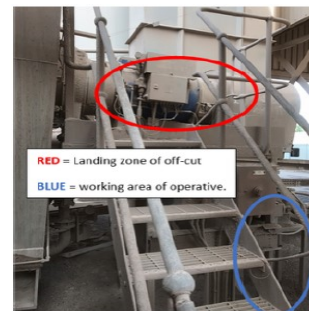
When the Fitter came to adjust the plate a sliver of metal fell through an open mesh and landed directly below on a platform where an operative was performing a greasing task close by.

Had the strip of Hardox steel plate struck the employee, there would have been a potential for serious injury.

- The RAMS for the task noted cutting the steel plate at ground level, and not at height.
- The task changed during the activity and not been noted on the Risk Assessment.
- No cordoned zone was established below when the task changed and no checks made by the fitter.

- The off-cut fell through open mesh flooring at height, missing an operative by 1 metre.
- The Fitter did not advise site Management of the task change but proceeded anyway.
- RAMS controls became ineffective as a result.
- Permit to Work - Hot works became ineffective

- Fitter re-inducted and trained in the process to follow.
- Review of contractual relationship with fitting contractor.
- Local Management re-trained in the Risk Assessment process.
- Implementation of a mid-task checklist for supervisory staff to carry out and audit checks during completion.
