# Bolt Tensioner Incident

**ALERT STATUS:** Normal  
**DATE ISSUED:** 17/03/2011  
**INCIDENT No:** 00285

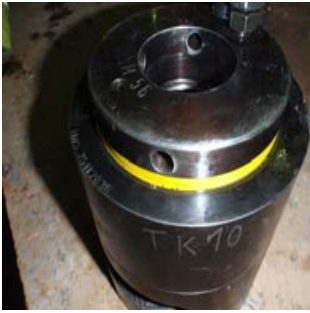
Ram

- Over extending the inner ram (which may be indicated by a yellow band – as in this incident) or a red band can result in loss of an effective seal.
- Over extension followed by subsequent retraction of the unit may affect the seal, but this will not be obvious from an external examination.
