Excavator Crush

Groundworker trapped by excavator.

LOCATION:	CONSTRUCTION/DELIVERY SITE	ALERT STATUS:	Normal
ACTIVITY:	MAINTENANCE & HOUSEKEEPING	DATE ISSUED:	04/04/2011
SUB ACTIVITY:	N/A	INCIDENT No:	00287

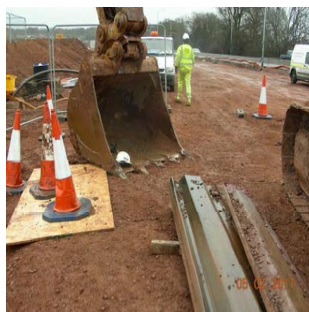
Bucket

An incident occurred recently within one of our group companies where a groundworker was trapped between the bucket and the track of a 35 tonne excavator. The operative was trapped just below the left knee, and tragically after multiple operations had to have his lower left leg amputated.

The principal causal factor was when the plant driver was climbing back into his cab following a conversation with the injured person, his coat snagged the slew/dipper arm control, and without realising that his coat was caught, he activated the “dead mans handle”.

The excavator was ‘ticking over’ in idle mode, as he climbed in but the machine was set in ‘high revs’. This deactivation of the safety device caused the machine bucket to travel at high speed in the

direction dictated by the snagged control lever.

At that very moment the IP was walking between the bucket and track of the machine. This was so he could continue a conversation with a third party who had arrived at the scene just before the incident, he became trapped between the bucket and the track.

Plant must be turned off when the operator exits the cab.

Managers of plant operations should review the start up procedures of plant items, in particular, thought should be given to a methodical approach to the start up of plant, this will allow the operator time to ensure the hazard area of the plant is clear of persons on the ground. Engaging 'low revs' would be part of this process.

Segregation of all pedestrians and plant must be reviewed.

Projects should review the type of PPE issued to plant operators.

Tool Box Talks, task briefings, STARRT talks or any work related conversations should be undertaken away from plant items in a safe place.
