# Potential Mixer Drum Entanglement

**09/05/2011**

**00289**

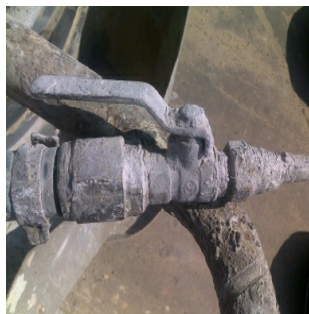
Mixer Tap

A serious incident occurred recently during the washing down of a mixer drum following discharged concrete. It is believed that the cause of this incident was the type of tap (see picture ).

The design of the tap, and dependant on where an individual washes the blades, could result in the tap becoming wedged in the mixer blade, pulling the hose and potentially the individuals hands/arm into the mixer.

These types of taps should be replaced with twist on/off taps.

Mixers should only be washed in discharge mode.

All 'guarding' of mixers should be assessed to ensure that it is adequate if a hose should become trapped.
