# Fall from Tipper

ALERT STATUS: Normal  
DATE ISSUED: 25/06/2011  
INCIDENT No: 00290

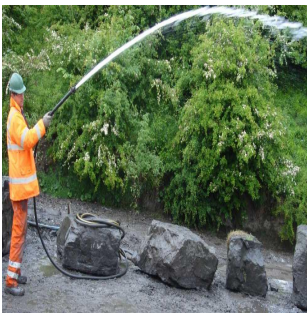
On inspection, the water pressure at the wash station was not sufficient to allow the 'jet' of water to reach the full length of a tipper (picture No:1) and this may have been the reason why the wash station was not used. Further investigation found that the wash station boost pump had tripped, once reset the station operated as intended (picture No:2).

Picture 2: Pump Working
