Chassis Failure Komatsu 350 Dumper

ALERT STATUS: Normal
DATE ISSUED: 05/07/2011
INCIDENT No: 00291

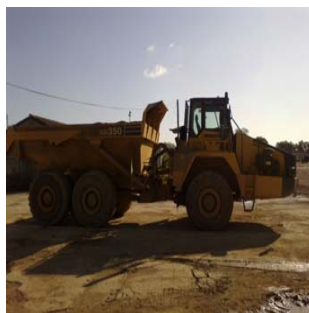
An inspection of the dumper was undertaken and it was discovered that the near-side tractor unit chassis had a large split running through it. This made the vehicle un-safe and it was immediately taken out of service.

- Pressure wash and conduct a thorough chassis inspection of all Komatsu HM 350 and HM400 dumpers.
- A known indicator of this problem is a widening of the gap where the battery box abuts the wheel arch.
- Where there is any doubt contact John Taylor, Product Support Manager at Marubeni Komatsu, who will arrange for a service engineer to visit. (Editors note: Other company's may need to make their own arrangements for a specialist inspection).

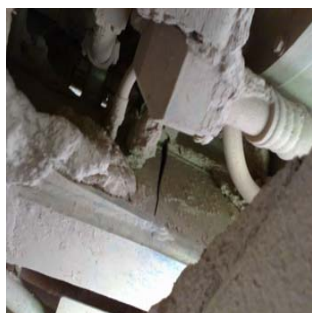
Split Chassis
