# Chassis Failure Komatsu 350 Dumper

**ALERT STATUS:** Normal  
**DATE ISSUED:** 05/07/2011  
**INCIDENT No:** 00291

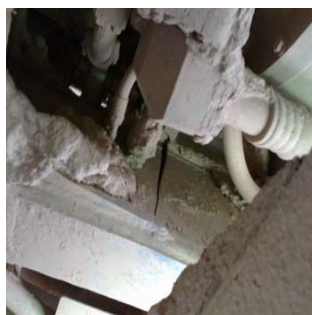
An inspection of the dumper was undertaken and it was discovered that the near-side tractor unit chassis had a large split running through it. This made the vehicle un-safe and it was immediately taken out of service.

Split Chassis

- Pressure wash and conduct a thorough chassis inspection of all Komatsu HM 350 and HM400 dumpers.
- A known indicator of this problem is a widening of the gap where the battery box abuts the wheel arch.
- Where there is any doubt contact John Taylor, Product Support Manager at Marubeni Komatsu, who will arrange for a service engineer to visit. (Editors note: Other company's may need to make their own arrangements for a specialist inspection).
