Insurance Inspector Near Miss

ALERT STATUS: Normal
DATE ISSUED: 17/08/2011
INCIDENT No: 00297

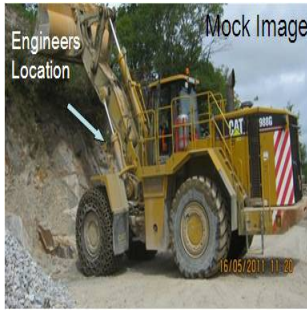
An insurance engineer was undertaking statutory inspections on a number of items of mobile plant at a UK Quarry. During the engineer's inspection of a CAT 998g loading shovel, the engineer was seen to be accessing the front of the Front End Loader (FEL) between the axles beneath a raised boom and bucket.

It was established that the loading shovel was switched off but the driver was still in the cab with the keys in the ignition. The plant operator had dropped the dead man switches to prevent movement of the stick controls, however he confirmed that he did not anticipate the engineer climbing on to the front of the FEL underneath the raised bucket.

When Questioned the FEL operator claims that the engineer could not be seen when he climbed on the front of the loader and eventually off over the wheel arch and front tyre.

- The Risk Assessment (RA) and Safe Working Practice (SWP) provided by the insurance company was not suitable & sufficient.
- The Quarry responsible manager did not effectively review the RA & SWP prior to issuing permission to proceed.
- The insurance engineer did not recognise the potential hazard of crushing / entrapment.
- The FEL operator was not fully briefed on the inspection method.
- The insurance company have a dynamic point of risk assessment tool, but the engineer was not aware of its existence and had not been trained in its use.

Always ensure that all task risk assessments manage all reasonably foreseeable hazards and the controls implemented are suitable and sufficient prior to issuing permission to proceed.
