Truck Mixer Driver suffers Amputation

LOCATION:	CONSTRUCTION/DELIVERY SITE	ALERT STATUS:	Normal
ACTIVITY:	TRANSPORT & LOGISTICS / DELIVERY	DATE ISSUED:	22/08/2011
SUB ACTIVITY:	PRODUCT DELIVERY	INCIDENT No:	00309

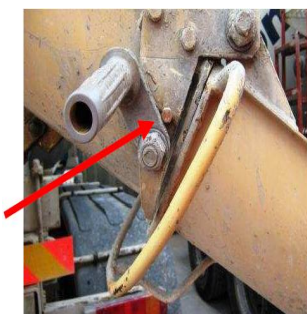
Shute with Bolt

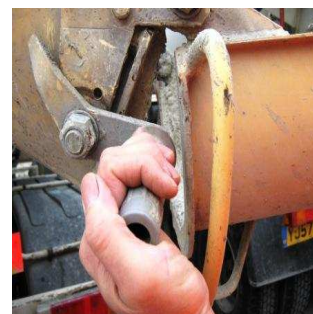
A truck mixer driver received crushing injuries resulting in the amputation of part of his little finger when the two handles in the picture came together when he operated the chute.

The bolt highlighted was missing and had not been replaced. This allowed the round bar handle on the second (lower) chute to impact against the safety catch handle on the upper chute which resulted in the injury.

Shute with Missing Bolt

The use of a small bolt to prevent the safety catch handle over rotating is being raised with the manufacturer of the mixer.

Ensure regular inspections are carried out.

Report all defects.

Ensure that remedial or repair work is promptly completed.
