# Fall into Unguarded Opening

**AGGREGATE DREDGER**  
**ACCESS & EGRESS & WORKING AT HEIGHT**  
**N/A**

**ALERT STATUS:** Normal  
**DATE ISSUED:** 16/01/2012  
**INCIDENT No:** 00321

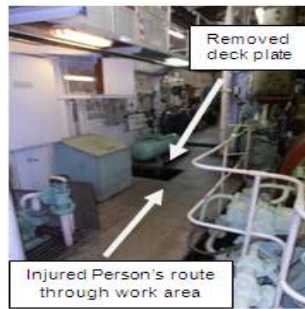
Incident Location

The Engineer who was fault finding briefly went below the removed deck plate to trace an air line. The Injured Person, who had completed his task, was returning his tools to the engine room workshop, via the area where the deck plate had been removed.

The Engineer who had been below the plates for about a minute then climbed out and turned to see the IP carrying the tools approaching him and the unguarded opening in the deck. The Engineer immediately challenged the approaching IP by putting his hand up to warn / stop him from proceeding towards the hazardous location where the plate had been removed (Note: ear protection was being worn in the engine room).

Unfortunately the IP failed to acknowledge the warning, as he was not looking where he was

going, and subsequently stepped into the unguarded opening, falling to the deck; he did manage to stop himself from falling completely into the opening. This resulted in the IP requiring hospital treatment, where he was treated for fractures to his lower right leg and cuts and bruising to his left leg and arm.
