# Cardox Shell Incident

**LOCATION:**  
**ACTIVITY:**  
**SUB ACTIVITY:**

**CEMENT PLANT**  
**PRODUCTION AND PROCESSING**  
**CEMENT PRODUCTION**

**ALERT STATUS:** Normal  
**DATE ISSUED:** 04/12/2012  
**INCIDENT No:** 00347

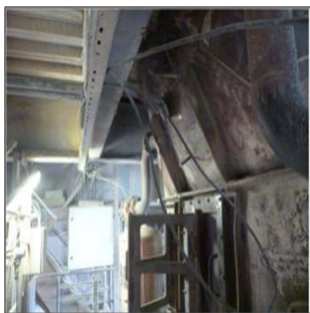
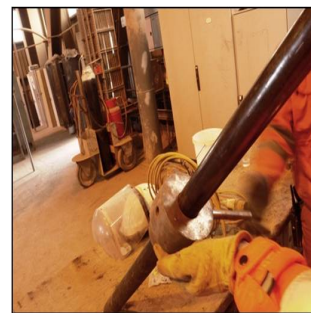
During routine cardox use, a shell was ejected from the retaining collar striking a hand rail and resulting in minor damage to a water pipe.

The shell has a slightly raised shoulder at one end which has a larger external diameter than the internal diameter of the centre of the collar. This prevents the shell from being ejected from the calciner when detonated – provided that the correctly sized collar is used.

The shell is “detonated” by an electric charge activating a heater unit in one end of the shell which instantaneously vaporises the carbon dioxide which explosively discharges through a bursting disc at the opposite end, breaking away build up.

Two sizes of retaining collar were available for use, the larger internal sized collar was being used with the smaller diameter shell.

A manufacturing defect had resulted in ridges at the welded seam of the shell projecting sufficiently for two of the shells being used not being able to fit

for two of the shells being used not being able to fit through the correctly sized collar.

This fault had been made worse as a result of Cardox increasing the wall thickness of the shell so that the overall external diameter had increased by 1mm, which was not known to the users.

The larger internal sized collar had been used with the smaller external diameter shells for some time prior to the incident because of the slight increase in diameter, the welding ridges and that some lateral movement was possible when inserting the cardox shell through the collar and into the calciner prior to detonation.

Both larger diameter collars removed from use and returned to Cardox.

Smaller diameter collars reamed to accommodate the slight increase in external diameter of the cardox shells.

Defective shells machined to remove ridges – Cardox reviewed their quality control procedures to ensure that defective shells cannot be issued in future.
