Cardox Shell Incident

CEMENT PLANT
PRODUCTION AND PROCESSING
CEMENT PRODUCTION

ALERT STATUS: Normal
DATE ISSUED: 04/12/2012
INCIDENT No: 00347

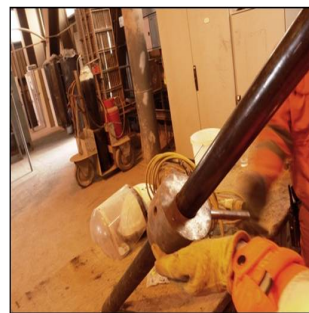
During routine cardox use, a shell was ejected from the retaining collar striking a hand rail and resulting in minor damage to a water pipe.

Charged cardox shells are inserted into a previously drilled hole in the side of the calciner.

The shells are retained in place by means of a

collar that is secured by a one quarter turn into a threaded opening in the wall of the calciner.

The shell has a slightly raised shoulder at one end which has a larger external diameter than the internal diameter of the centre of the collar. This prevents the shell from being ejected from the calciner when detonated – provided that the correctly sized collar is used.

The shell is “detonated” by an electric charge activating a heater unit in one end of the shell which instantaneously vaporises the carbon dioxide which explosively discharges through a bursting disc at the opposite end, breaking away build up.

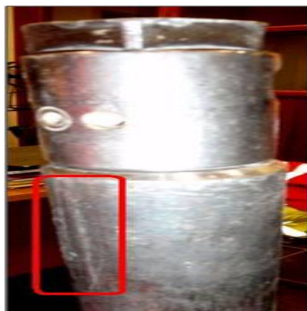
Two sizes of retaining collar were available for use, the larger internal sized collar was being used with the smaller diameter shell.

A manufacturing defect had resulted in ridges at the welded seam of the shell projecting sufficiently for two of the shells being used not being able to fit

for two of the shells being used not being able to fit through the correctly sized collar.

This fault had been made worse as a result of Cardox increasing the wall thickness of the shell so that the overall external diameter had increased by 1mm, which was not known to the users.

The larger internal sized collar had been used with the smaller external diameter shells for some time prior to the incident because of the slight increase in diameter, the welding ridges and that some lateral movement was possible when inserting the cardox shell through the collar and into the calciner prior to detonation.

Both larger diameter collars removed from use and returned to Cardox.

Smaller diameter collars reamed to accommodate the slight increase in external diameter of the cardox shells.

Defective shells machined to remove ridges – Cardox reviewed their quality control procedures to ensure that defective shells cannot be issued in future.

A further effect of the review was that all shells currently in use would be withdrawn and replaced with shells uniquely identified with a reference number.

Each time a shell is used it is now logged – this would enable the shells to be completely removed from service after 1000 uses in line with Cardox's recommendations.
