Operator bruises hand due to release of stored energy in operation to free stuck davit (lifting device) - BMAPA Alert

LOCATION: AGGREGATE DREDGER
ACTIVITY: MAINTENANCE & HOUSEKEEPING
SUB ACTIVITY: N/A

ALERT STATUS: Normal
DATE ISSUED: 06/10/2020 10:33:40
INCIDENT No: 03570

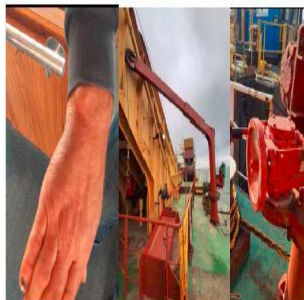
While moving a stuck lifting davit which was wedged under a fire main pipe with the use of a chain block onboard a UK marine aggregate dredger, the slewing wheel hit the IP's hand causing bruising when the davit arm released.

To free the boom of the davit a chain block was rigged so the boom would be pulled downward and outward. While the boom was loaded up by the chain block the boom came free from under the pipe and moved suddenly outboard. At this point the slewing wheel spun round where upon the handle of the wheel struck the IP on the back of the hand.

Prior to this incident the discharge boom was moved past its normal operating parameters at a wharf to facilitate discharge. The hazards involved had not been clearly identified as the boom conveyor struck the davit and pushed the davit underneath the fire main where it became stuck. No formal Risk Assessments were in place for either the movement of the discharge boom to facilitate discharge beyond normal operating parameters, or the subsequent freeing of the davit back into its normal position.

A formal RA may have identified the potential of hitting the davit in the first place and subsequently the release of stored energy when the boom was released by the chain block.

- When conducting Risk Assessments ensure all hazards are clearly identified especially when identifying the potential of stored energy being present.
- Any operational equipment being moved beyond its normal operating parameters must be fully risk assessed and approved by the Ship Manager beforehand, except if for "preservation of life", the ship or the environment under the master's discretion.
