Fatal 1 - BMAPA Alert - Stored energy/Stress in a damaged hull

LOCATION:	AGGREGATE DREDGER	ALERT STATUS:	Normal
ACTIVITY:	MAINTENANCE & HOUSEKEEPING	DATE ISSUED:	30/10/2020 11:16:10
SUB ACTIVITY:	N/A	INCIDENT No:	03573

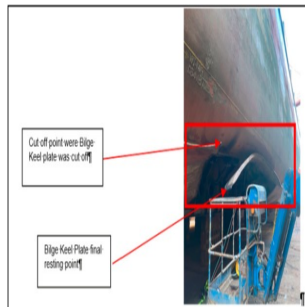
A contractor working in a UK ship repair yard was removing a section of damaged bilge keel by oxy acetylene burning. When reaching the end of his cut the stored energy / stress in the deformed bilge keel caused the plate to release downwards then upwards violently hitting the contractor on the chest, shoulder, jaw and head.

Fortunately, this did not end up with any life changing major injuries but it could have and it was completely avoidable if a task specific risk assessment had been completed.

- All tasks in a repair yard should be fully risk assessed to identify all risks present and not presume or assume personnel (including contractors/sub-contractors) understand all risks associated with tasks.

- Personnel are required to sign off the risk assessment for the task to confirm they have read and understood.
- Repair yards to ensure they have risk assessments in place for “Removing Material under stored energy”

- One-to-one briefing of workers by supervisor or manager to ensure they understand the method statement and associated risk controls.
- Any potential stored energy release tasks must be classed as high risk

- Specific control points are to be put in place to remove damaged hull plating in small sections with all plating / frames under stress marked up with cut lines / cut sequence

- Any plate being removed must be supported / restrained to control any release of stored energy
- Daily project meetings must ensure all high-risk activities are discussed and all associated work is properly planned.
