Operator sustains grazed/bruised back from contact with scaffolding -non-treatment injury - BMAPA Alert

LOCATION: AGGREGATE DREDGER
ACTIVITY: ACCESS & EGRESS & WORKING AT HEIGHT
SUB ACTIVITY: N/A

ALERT STATUS: Normal
DATE ISSUED: 03/12/2020 12:28:45
INCIDENT No: 03577

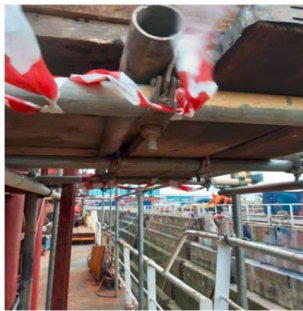
A UK marine aggregate dredger was undergoing its annual dry dock. Scaffolding had been erected in the vicinity of the aft screening tower to facilitate its removal. The scaffolding was erected across the starboard side walkway which restricted the walkway, with the scaffolding platform only being 1.5m above the spillway. The erected scaffolding had red and white hazard tape applied to highlight the low height of the scaffolding and the protruding scaffolding clips whilst waiting on delivery of protective foam.

The IP transited this walkway for general access to the engine room and in doing so, whilst crouched down, impacted his back on the protruding scaffolding clips. This caused a small abrasion and bruise on the left side under the shoulder.

It has been identified that there was inattention to immediate surroundings as the scaffolding was highlighted with hazard tape.

- Staff to discuss the importance of paying attention to their immediate surroundings and the importance of making informed decisions where normal access routes may be restricted during maintenance periods.
- Ensure scaffolding has been fully completed, including foam protection fitted before signed off and used as a thoroughfare.
