Fatal 6 - Lifting operation LTI injury - BMAPA Alert

LOCATION: AGGREGATE DREDGER
ACTIVITY: LIFTING
SUB ACTIVITY: NO SUB ACTIVITY AVAILABLE

ALERT STATUS: Normal
DATE ISSUED: 03/12/2020 16:24:47
INCIDENT No: 03580

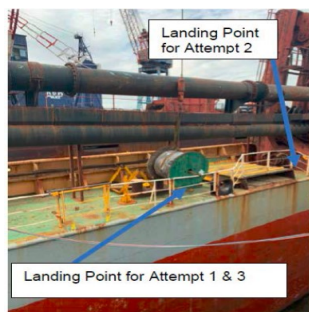
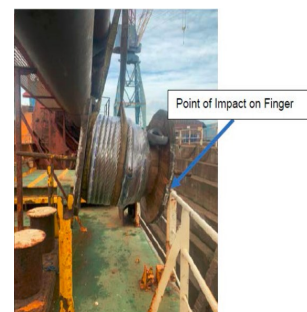
A decision was then made to move back to the original location and the trestles were set up in this location. The wire reel was lifted on-board, a cross bar was then inserted through the centre of the reel to facilitate rotating the reel into the fore and aft direction. During the rotation, the reel moved more quickly than in the previous attempts, it was at this point the IP sustained a crush injury to his left forefinger. The reel crushed his finger against the upright stanchion of the hand railings.

- The dimensions of the reels used to dispatch replacement wires are not a standard size.
- If a particular size is required to fit an existing support trestle or to enable access through a hatchway to the hold for storage then it should be specified at the point of order.

- All vessels to discuss this incident in detail at the next available opportunity and ask "...could this happen on my watch?"
- All vessels to reflect on risk assessments for changing wires to ensure effective hazard identification has been completed.
