Inspection on a Komatsu loading shovel identifies serious fault in wheel rim

ALERT STATUS: **High Potential**
DATE ISSUED: 12/01/2021 17:13:56
INCIDENT No: 03582

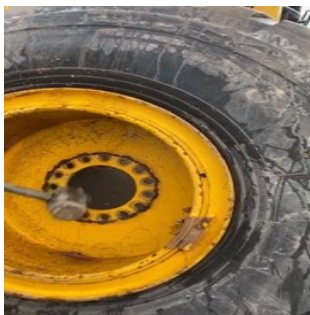
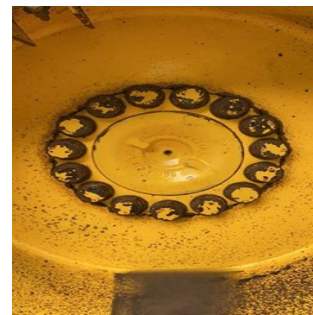
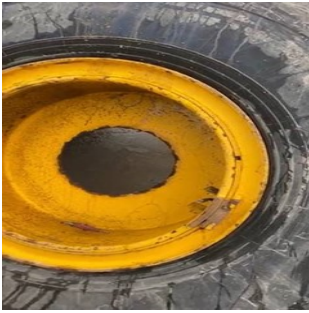
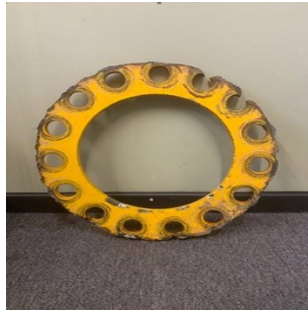
During an inspection carried out by our engineer on a Komatsu WA 320 Loading Shovel at an asphalt plant, it was noted that there was a crack travelling from the holes of each wheel stud. At first glance, it probably looks like only the paint work had cracked, but after cleaning the area with a pressure washer and closer inspection, it was confirmed that this was actually a crack in the rim itself.

The machine was immediately put into quarantine and further inspection carried out; another hair line crack was found on the opposite wheel and another in one of the front wheels. This could have potentially caused a major equipment failure with catastrophic consequences.

- Four new wheel rims were ordered and fitted by an external Tyre company.
- We are in the process of checking all other shovels, but this seems like an isolated incident.
- The main dealer was contacted as part of the investigation, who have passed this info directly onto the manufacturers Komatsu and awaiting any additional information.
- All managers are to emphasise the importance of Vehicle and Plant daily checks and not just to tick the sheet, making sure plant is kept in the cleanest of conditions as dirt can easily mask or mislead the operator.
