Inspection on a Komatsu loading shovel identifies serious fault in wheel rim

ALERT STATUS: **High Potential**
DATE ISSUED: 12/01/2021 17:13:56
INCIDENT No: 03582

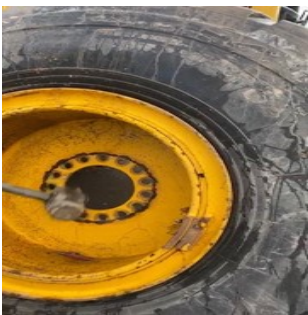
During an inspection carried out by our engineer on a Komatsu WA 320 Loading Shovel at an asphalt plant, it was noted that there was a crack travelling from the holes of each wheel stud. At first glance, it probably looks like only the paint work had cracked, but after cleaning the area with a pressure washer and closer inspection, it was confirmed that this was actually a crack in the rim itself.

The machine was immediately put into quarantine and further inspection carried out; another hair line crack was found on the opposite wheel and another in one of the front wheels. This could have potentially caused a major equipment failure with catastrophic consequences.

- Four new wheel rims were ordered and fitted by an external Tyre company.
- We are in the process of checking all other shovels, but this seems like an isolated incident.
- The main dealer was contacted as part of the investigation, who have passed this info directly onto the manufacturers Komatsu and awaiting any additional information.
- All managers are to emphasise the importance of Vehicle and Plant daily checks and not just to tick the sheet, making sure plant is kept in the cleanest of conditions as dirt can easily mask or mislead the operator.
