# Operator injured by arm rest on CAT 980

ALERT STATUS: Normal  
DATE ISSUED: 30/11/2021 18:07:45  
INCIDENT No: 03599

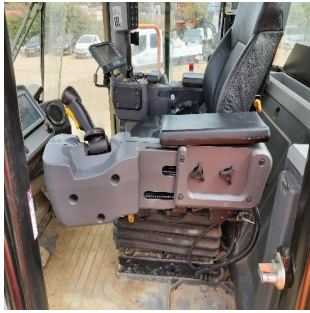
Armrest down

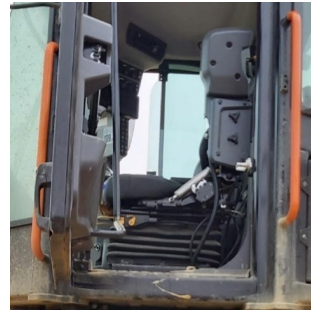
Armrest in up position to allow access

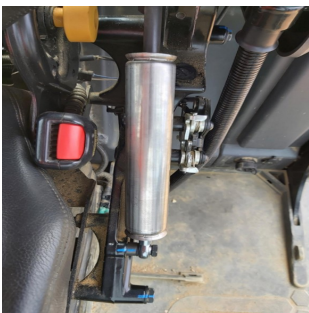
An investigation identified that the connecting pin attaching the piston ram to the seat had sheered. At the time of the incident, the machine was three months old. Two other CAT 980s (delivered at same time) were also found to have a similar issue with the arm rest. All arm rests have now been modified in accordance with manufacturers instruction.

Faulty piston

1. If something does not work as expected, it should be treated with extreme caution as it could be in an unsafe condition and not react as expected. Ensure body parts are kept clear from potential nip points.
2. Arrange with supplier for inspection to be undertaken of CAT 980 armrest.
