# Loading shovel tyre explosion

**LOCATION:** QUARRY  
**ACTIVITY:** MAINTENANCE & HOUSEKEEPING  
**SUB ACTIVITY:** N/A

**ALERT STATUS:** Normal  
**DATE ISSUED:** 27/01/2022 11:20:20  
**INCIDENT No:** 03603

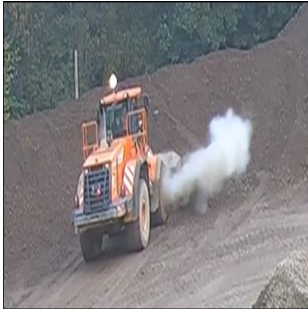
A front end loader was digging into a quarry aggregate stockpile when its front offside tyre suddenly exploded. No other vehicles or pedestrians were in the area and the operator was unharmed.

Tyre exploding on video

- Always thoroughly inspect machine tyres when doing pre-start safety checks (and record it).
- Stay vigilant for signs of damage or defects during the shift. Look for signs of impact or destructive damage (bulges or deformation of the tyre sidewall or tread, exposed reinforcing wires, damage to wheel rims, loss of tyre pressure, etc.)

- If any significant damage is found – STOP - do not operate the machine, park it up and cordon the machine off until the tyre has been examined by a professional tyre fitter (earthmoving tyre specialist)

- Earthmoving tyres should be subject to regular inspection (and maintenance, as required) by a professional tyre maintenance company – The inspection frequency should be agreed with the service provider based on their professional recommendation and advice.

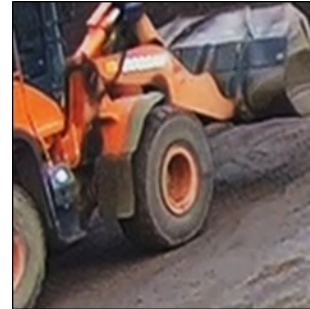
Site cctv footage shows a bulge develop on the sidewall of the tyre shortly before it exploded. Footage from earlier in the day appears to show (but not conclusively) some sidewall deformation already present.

Tyre bulge prior to explosion
