Loading shovel tyre explosion

ALERT STATUS: Normal
DATE ISSUED: 27/01/2022 11:20:20
INCIDENT No: 03603

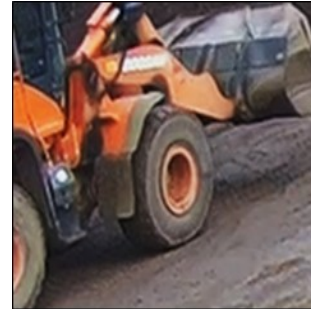
Site cctv footage shows a bulge develop on the sidewall of the tyre shortly before it exploded. Footage from earlier in the day appears to show (but not conclusively) some sidewall deformation already present.

Tyre exploding on video

Tyre bulge prior to explosion

- Always thoroughly inspect machine tyres when doing pre-start safety checks (and record it).
- Stay vigilant for signs of damage or defects during the shift. Look for signs of impact or destructive damage (bulges or deformation of the tyre sidewall or tread, exposed reinforcing wires, damage to wheel rims, loss of tyre pressure, etc.)

- If any significant damage is found – STOP - do not operate the machine, park it up and cordon the machine off until the tyre has been examined by a professional tyre fitter (earthmoving tyre specialist)
