Fatal 5 - Lifting eyebolt failure

LOCATION:	QUARRY	ALERT STATUS:	Normal
ACTIVITY:	LIFTING	DATE ISSUED:	27/01/2022 11:42:49
SUB ACTIVITY:	NO SUB ACTIVITY AVAILABLE	INCIDENT No:	03604

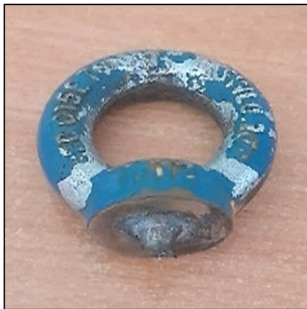
When the motor and gearbox were lifted the eyebolt failed (snapped off at the collar) and the load fell 750mm onto the plant walkway.

The lifting eyebolt was designed for lifting the motor only, with a safe working load of 300kgs. The combined weight of the motor and gearbox was 400kgs (eyebolt/load was therefore 100kgs overloaded).

The weight of the gearbox offset the load, preventing a balanced vertical lift and creating lateral shear force on the eyebolt. The eyebolt is designed for lifting the motor vertically.

Sheared eyebolt

- All lifting operations must be properly planned by a competent person, appropriately supervised and carried out in a safe manner – in accordance with LOLER Regulations – Regulation 8
- The use of a mobile crane and/or alternative lifting attachments (slings, etc.) should be considered when developing a Lift Plan.
- **NEVER** exceed the safe working load of lifting equipment. If something changes during the job – remember to **STOP** and reassess the risks.

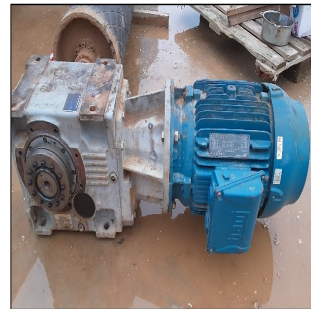
The motor shaft was seized onto the gearbox preventing the two items being split and lifted separately.

Motor and gearbox (eyebolt socket on motor)
