Although a direct strike of overhead lines avoided , 400v lines arc to tipper at delivery site

ALERT STATUS: High Potential
DATE ISSUED: 18/05/2022 19:35:29
INCIDENT No: 03615

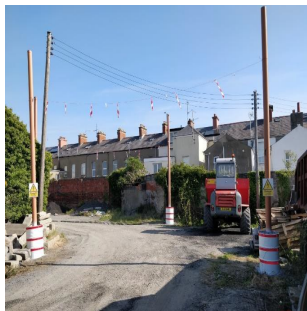
Goal posts, signage and bunting added at the site

- A company memo was issued highlighting the incident, the importance of treating each and every tipping situation with the same level of caution and the correct procedure for disposing of waste materials left over from site.
- The procedure for dealing with excess materials from site was added to company induction pack.
- A safety alert was circulated to all personnel and added to toolbox talks manual.
